South Florida Water Management District
EAA Reservoir A-1 Basis of Design Report

TASK 5.3.4.7.2 EVALUATION OF PMP/PMF AND DAMBRK SUMMARY TECHNICAL MEMORANDUM

Task 5.3.4.7.2 Evaluation of PMP/PMF and DAMBRK Summary Technical Memorandum

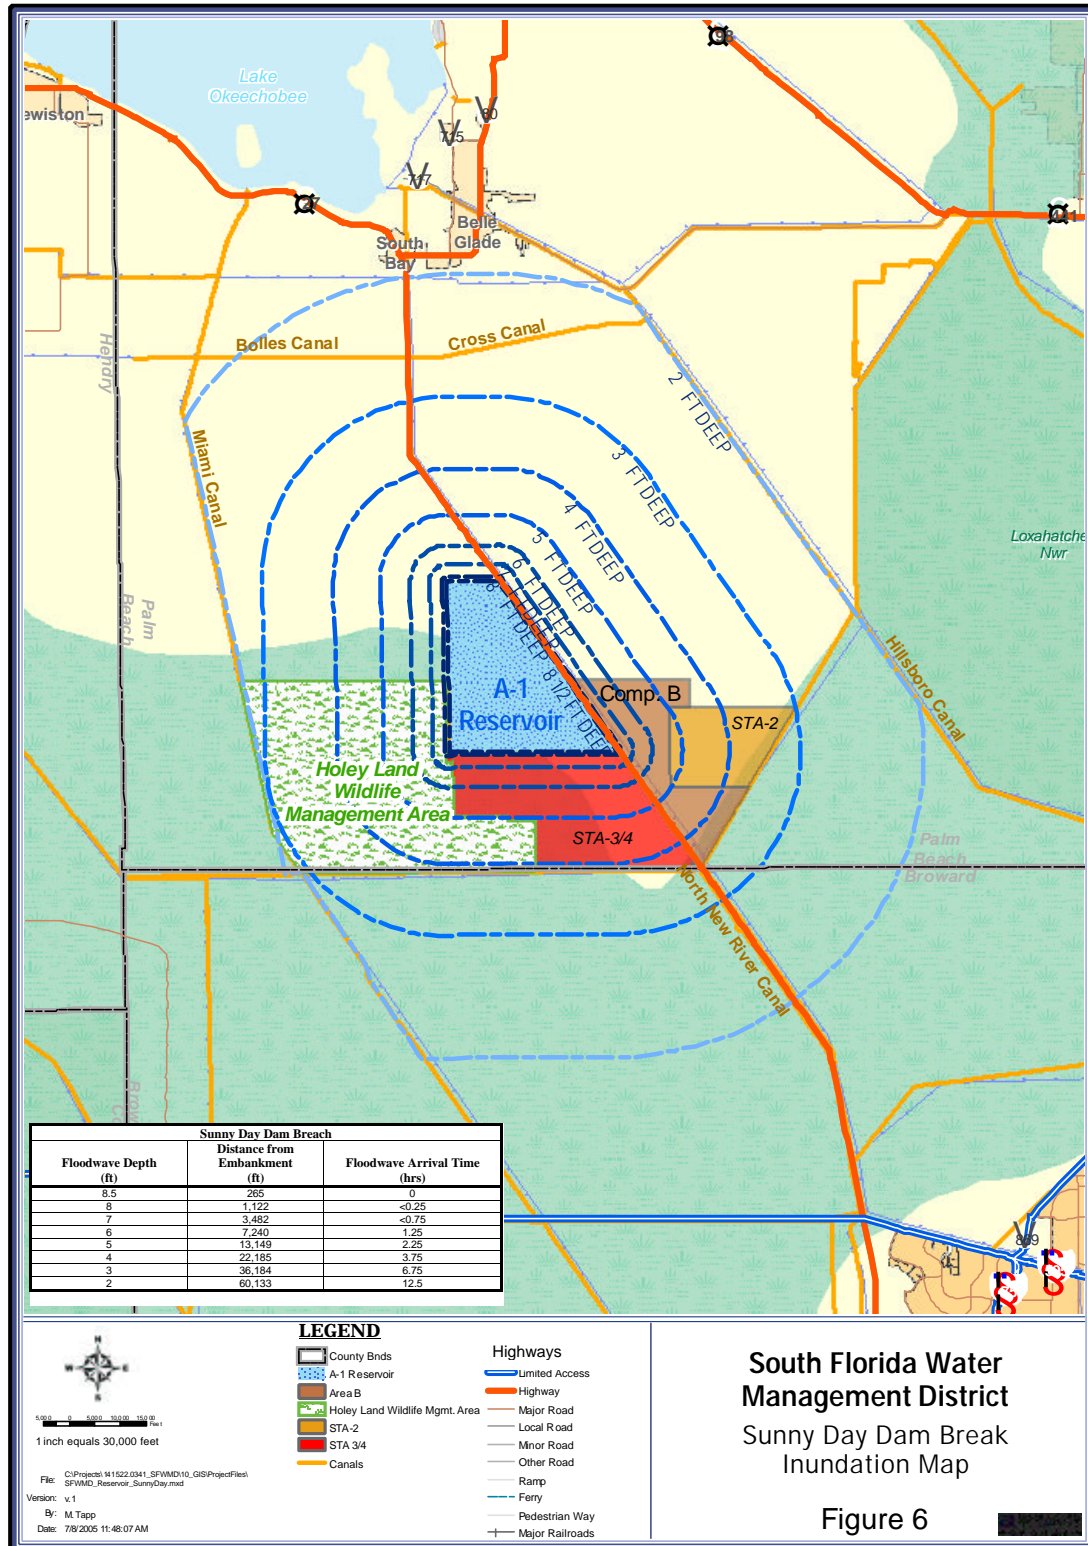
Figure 5 Sunny Day Dam Break Inundation Map

In all cases, the aerial extents of the PMP breach were determined to be greater than the Sunny Day breach. See Figures 5 and 6 for a pictorial representation of the results and Tables 1 and 2 for a written representation of the results.
